# Vibration Analysis Report

Example Company Limited, Example Town,  
UK: 7<sup>th</sup> April 2007.

**Report Content(s):** Furnace Exhaust Fan Vibration Tests.

**Our Reference Number:**  
HA07-03

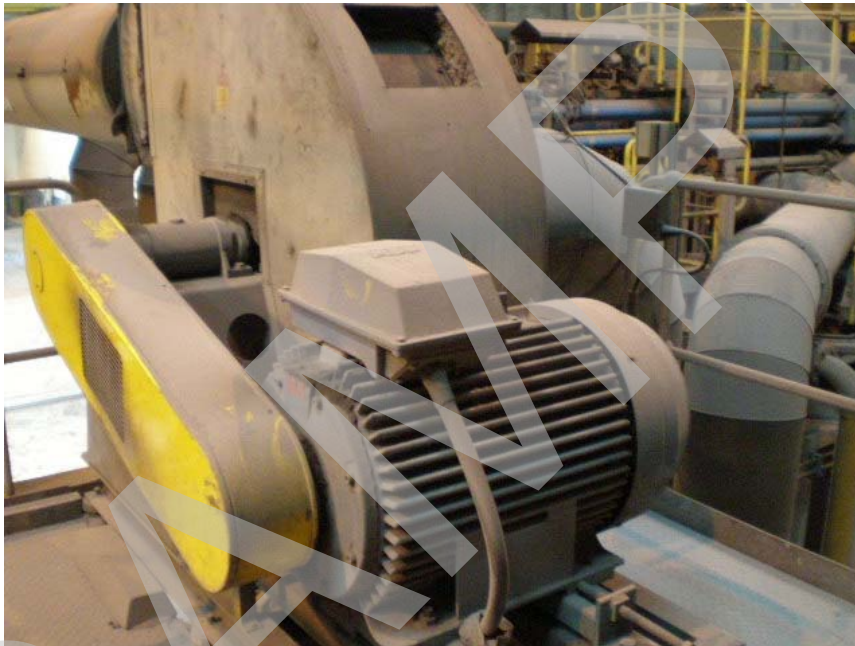
Figure 1: Photograph showing the layout of the Furnace Exhaust Fan located at Example Company.

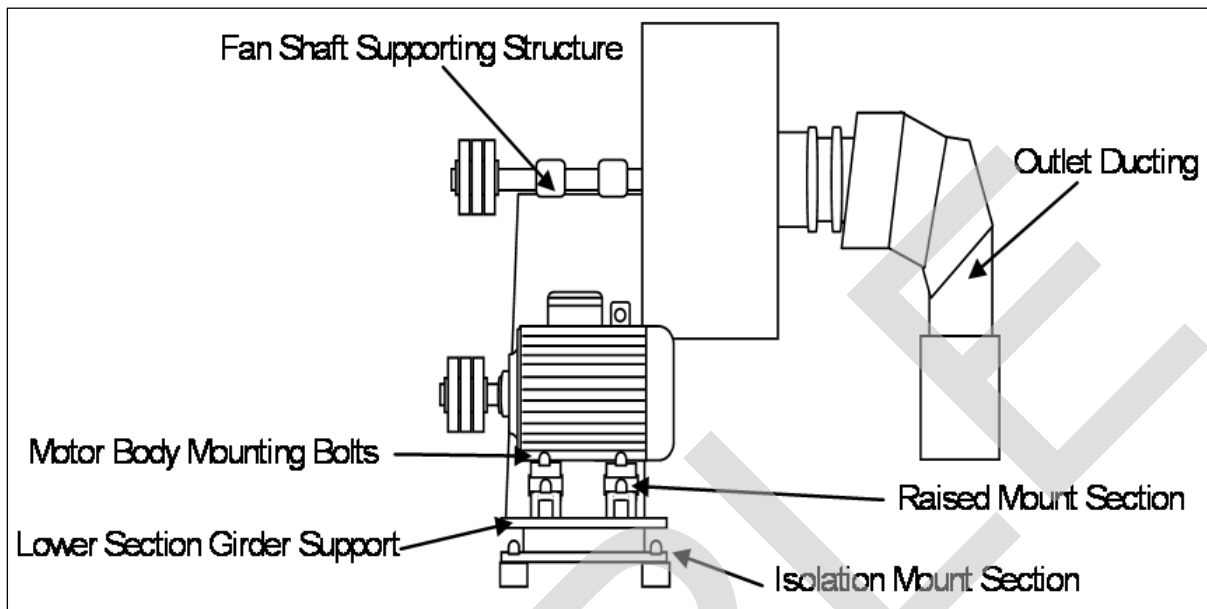
Figure 2: Diagram identifying the different support levels tested for possible resonance related problems.

The resonance tests conducted on the supporting structure and ducting revealed two locations of concern:

- (i) The '**raised mount section**' of the motor on the *drive side* position (nearest the pulley) identified a signal approaching one of the *belt passing* frequencies at 11.30 and 15.30 Hz frequencies.
- (ii) The **outlet ducting** revealed a natural frequency of 14.10 Hz frequency, also close to one of the natural *belt passing* frequencies of the installation.

It was also noted that the *inlet ducting* on the opposite side of the impeller casing showed multiple harmonics, any one of which may cause resonance related problems with the installation.

In conclusion, it is thought that the outlet ducting would not interfere with the overall vibration levels experienced on the machine, as the ducting was separated by pieces of material, specifically fitted to avoid any transmission of resonance from one part of the structure to another.

More importantly, the raised mounted section on the *drive side* of the motor may cause resonance related problems leading to imbalance on the installation. The simplest solution would be to ensure all welds are intact at this position and re-weld or build-up additional welds where necessary. It is also advised that the mounting section here is the 'weaker' part of the supporting structure, and it is essential all mounting bolts should be tightened to the correct torque (over-tightening can cause a condition known as 'sprung foot' where the frame becomes distorted, particularly effecting amplitudes at 1x RPM).

In addition to the *force imbalance* occurring on the *fan non drive end* bearing, there is a *couple imbalance* occurring on the *motor drive end* bearing within the *horizontal* plane. There is evidence to suggest that the supporting frame below the drive end of the motor is flexing, causing a 180° phase shift between readings; this can be corrected by reinforcing/replacing the supporting frame and ensuring all welds are intact (please refer to Diagram 2 on page 7 for details).

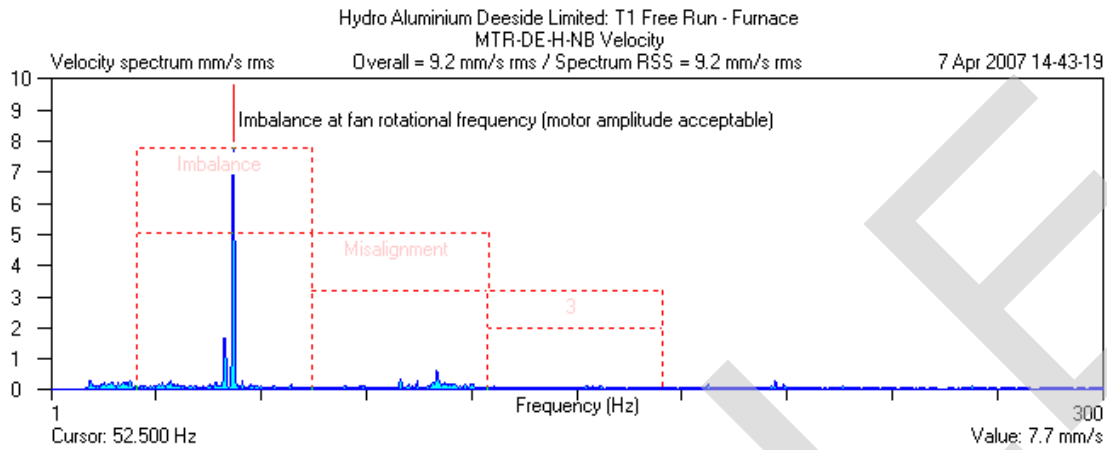
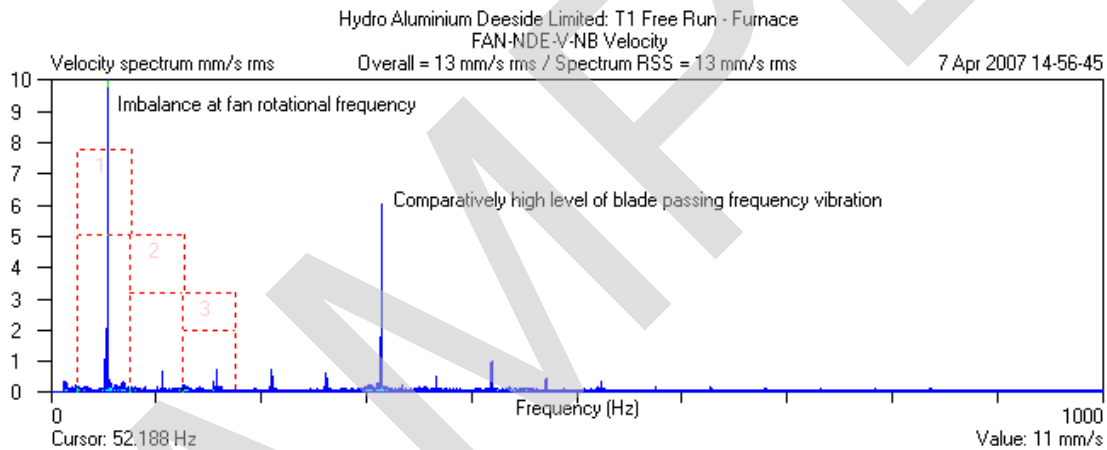
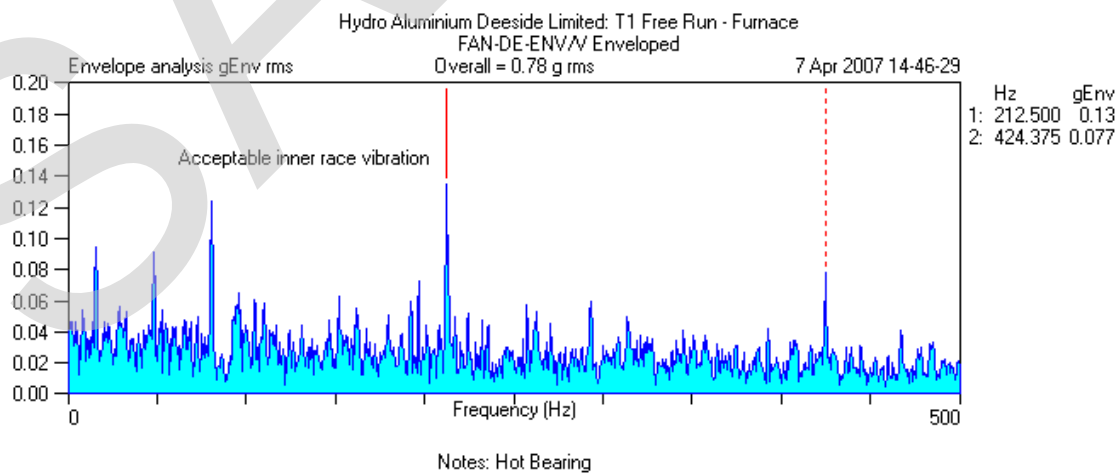
The results of this test revealed the installation was operating above the '**Unacceptable Zone**' as specified by the Vibration Severity Standard: **ISO10816-3**. The *vertical imbalance* detected on the *fan non drive end* bearing (i.e., the bearing nearest the impeller) attained a *velocity* amplitude of 11.0 mm/sec. at 52.188 Hz frequency. Additional readings also highlighted the possibility of an *eccentric pulley* located on the *motor drive end* bearing, where *belt passing* frequencies attained a *velocity* amplitude of 7.70 mm/sec. at 52.50 Hz frequency within the *horizontal* plane (as well as fluctuating amplitudes on the same position in the *vertical* plane).

It was noted that the *fan drive end* bearing became very hot in a relatively short period of time during this particular test; however, additional *enveloping* analysis revealed no untoward bearing related problems associated with the installation. Further readings identified a comparatively high level of *blade passing frequency* vibration in the *vertical* plane on the *fan non drive end* bearing, attaining a *velocity* amplitude of 6.0 mm/sec. at 313.438 Hz frequency. Although *blade passing* frequencies are naturally inherent in *fans*, *pumps* and *compressors* etc., a higher-than-average amplitude may indicate possible diffuser ring wear (uneven impeller rotation); obstructions in ducting and/or eccentric fan rotor.

**Figure 3:** Non-synchronous FFT vibration spectra obtained at various monitoring positions of the Furnace Exhaust Fan.

The Exhaust Furnace Fan located at Example Company proved to be operating above the '**Unacceptable Zone**' as specified by the Vibration Severity Standard: **ISO10816-3**. The *force imbalance* occurring on the *fan non drive end* bearing attained a *velocity* amplitude of 11.0 mm/sec. at 52.188 Hz frequency within the *vertical* plane, which can be corrected by placing a single balance weight on the impeller.

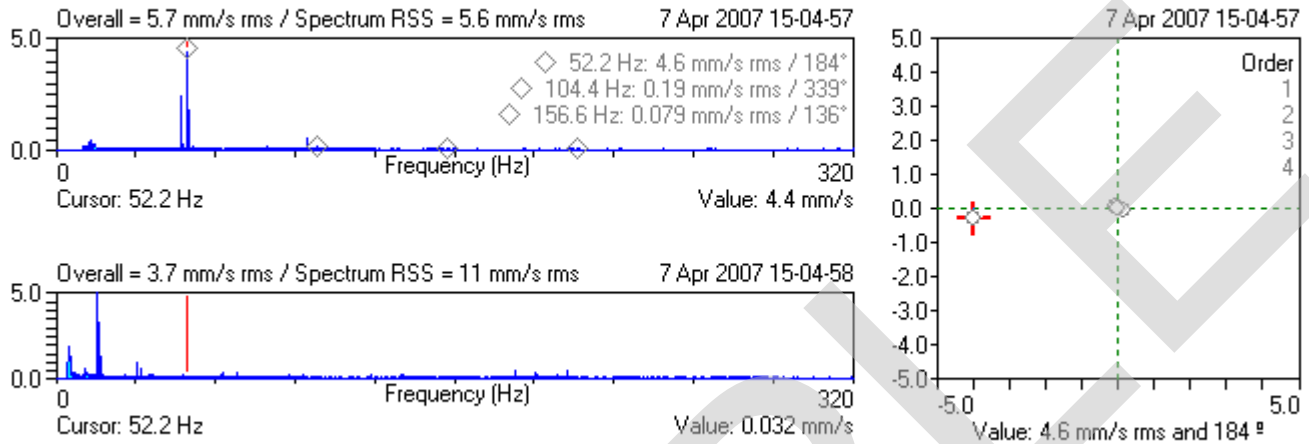
The results of Test 3 reveal there is no evidence to support the theory of an eccentric or offset pulley, where a phase difference of 0° or 180° is expected between relative *vertical* and *horizontal* positions. However, it was noted that the phase relationship on the motor revealed a typical 'couple imbalance' where balancing would require the placement of weights in at least two planes to correct (i.e., a phase difference of approximately 180°). The phase relationship identified on the fan bearings identified a typical 'force imbalance', where only one balance weight would be required to correct vibration to acceptable limits.

Hence, it is concluded that there are two types of imbalance affecting the installation; a 'couple imbalance' on the motor and 'force imbalance' on the impeller. The 'couple imbalance' identified on the motor may be attributed to the supporting frame 'flexing' and becoming distorted (it was noted also that the amplitude fluctuated greatly in the vertical plane on the motor).

**Figure 5:** Dual spectra taken from the vertical positions of the motor on the *non drive end* and *drive end* positions, identifying the combined phase relationship between the locations of the two sensors.

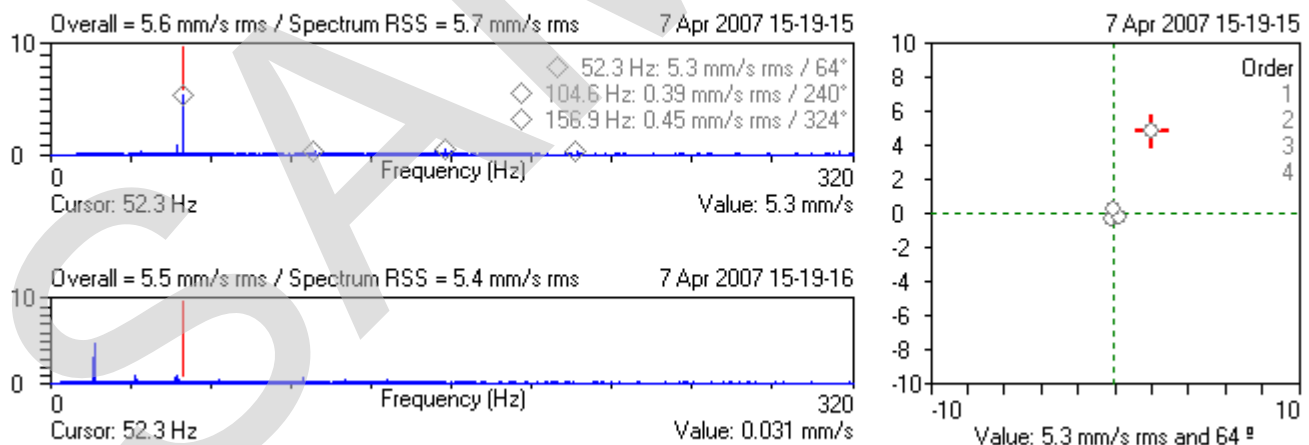
**Figure 6:** Dual spectra taken from the horizontal positions of the fan bearings on the *non drive end* and *drive end* positions, identifying the combined phase relationship between the locations of the two sensors.

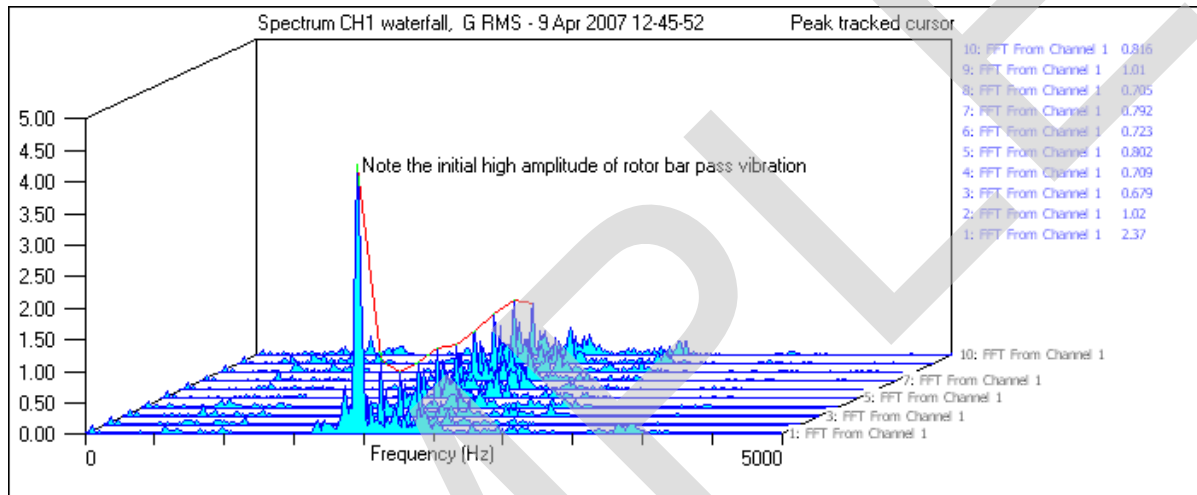
The results of Test 4 highlighted an unacceptable *acceleration* amplitude observed on the *motor non drive end* bearing in the *vertical* position, attaining an amplitude of 15.70 g peak during a 'coast-up' analysis. It is thought that the high amplitude witnessed here is the result of operating the installation from a stand-still position to full load (i.e., no soft start) resulting in the rotor taking over 6 seconds to locate its magnetic centre (the results of the waveform equate to rotor bar passing frequency).

**Figure 8a:** FFT Waterfall spectrum showing coast up analysis of motor measured on the *non drive end* bearing within the *vertical* plane. The initial levels of rotor bar pass vibration is considerably high in amplitude, but settles to an acceptable amplitude following 6 seconds of operation.

During the coast up/down tests, it was noted that the internal rotor took over 6 seconds to settle down from an initial start up period, resulting in some very high amplitudes of *rotor bar passing* frequency vibration before magnetic centre was established. In addition to the internal rotor unsettling period, the fan impeller also revealed higher-than-expected levels of *blade passing frequency* vibration over the same time period of 6 seconds, indicating the two faults may be interrelated (i.e., 6 seconds is the joint time taken for the aerodynamic related properties of the impeller and rotor bar passing elements to settle).

There is a danger of the rotor rubbing against the motor casing in this instance and the case for a soft-start system is should be seriously considered, due to the amplitudes observed here. Likewise, if the impeller becomes eccentric or unstable during start-up, the blades may touch the outer casing, resulting in damaged edges and uneven air gaps.

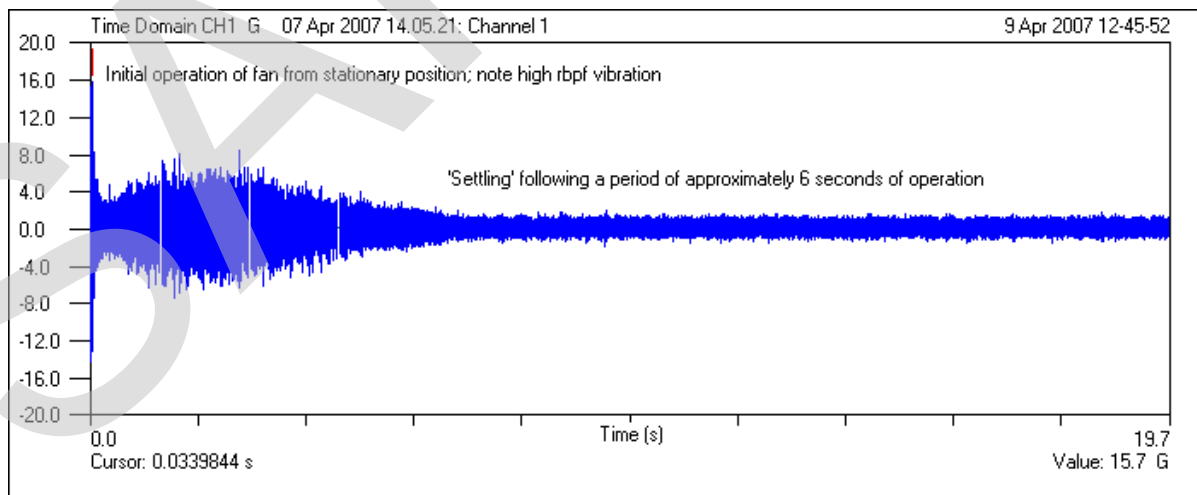
**Figure 8b:** Time waveform taken over a 19.70 second period collected from the same monitoring position as figure 4a. Note the initial 'unsettling period' (identified as a 'swelling') clearly showing unsteady rotor bar passing vibration.

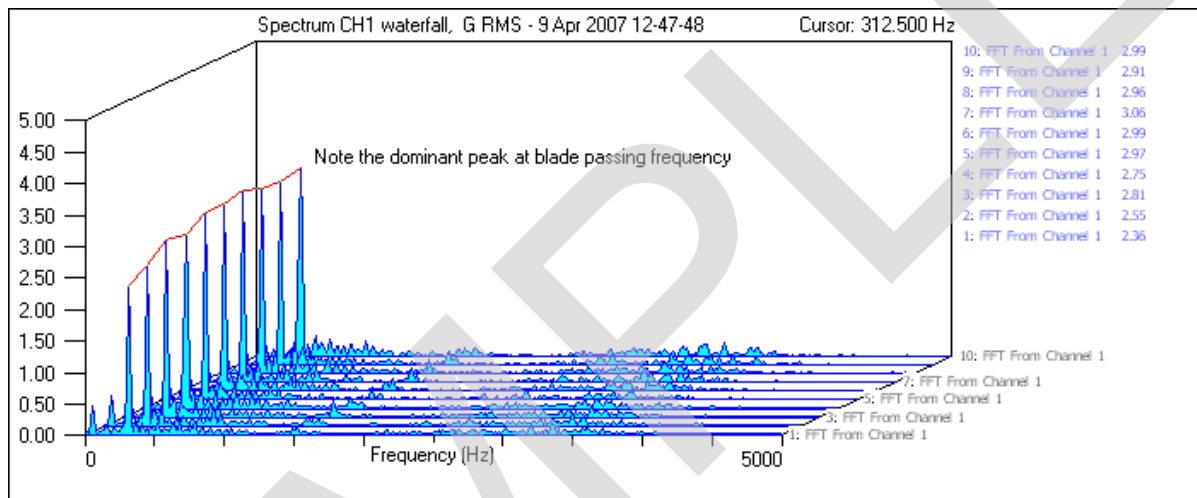
In addition to the initial rotor bar passing vibration identified on the *non drive end* monitoring position of the motor, the coast up/down analysis revealed some unsettling on the *fan non drive end* bearing, also over a period of 6 seconds and resulting in high-than-expected amplitudes (10.90 g peak). The aerodynamics of the fan impeller is thought to be attributable to the unsettling period witnessed here and this had been identified as a comparatively high amplitude of *blade passing frequency* vibration.

The opposing *fan drive end* bearing also revealed an increase in levels, albeit at a lower amplitude than the *fan non drive end* bearing. It is also noteworthy that these higher amplitudes have been observed in the *vertical* plane on both fan bearings and the *motor non drive end* bearing.

**Figure 9a:** FFT Waterfall spectrum showing coast up analysis of fan non drive end bearing measured within the *vertical* plane. The initial levels of blade passing vibration are unsettled due to the aerodynamic properties of the installation.

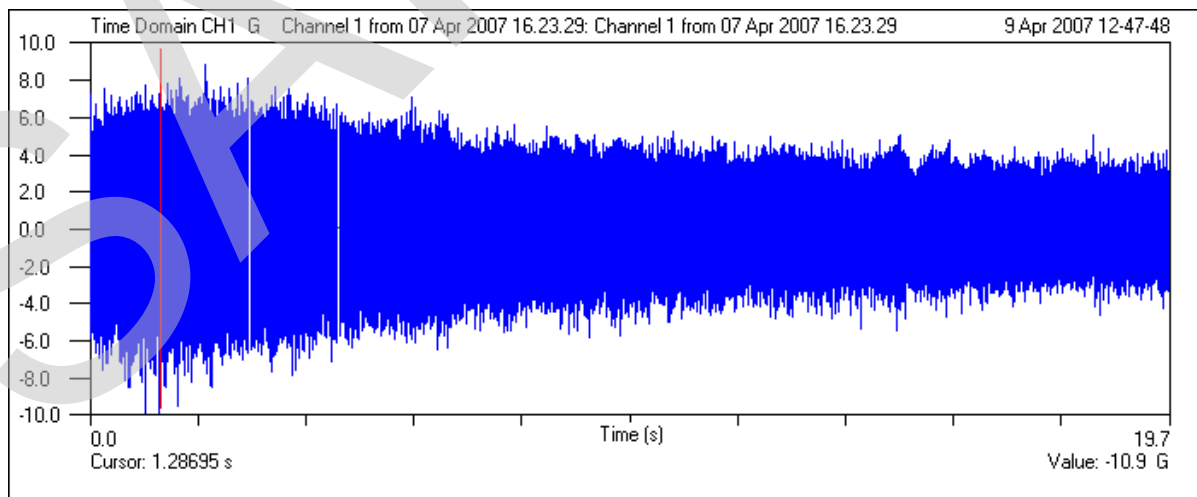
**Figure 9b:** Time waveform taken over a 19.70 second period collected from the same monitoring position as figure 4a. Note the initial 'unsettling period' (identified as a 'swelling') at the beginning of the waveform.
